HMMWV...

OIL COOLER FAILURE DEAD-LINES TRUCK!

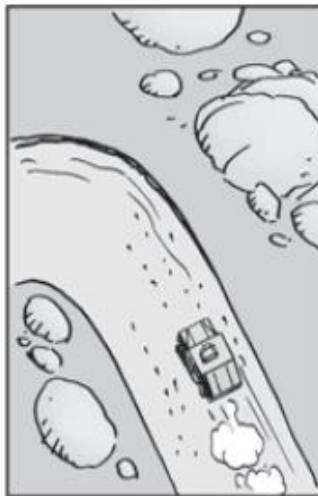
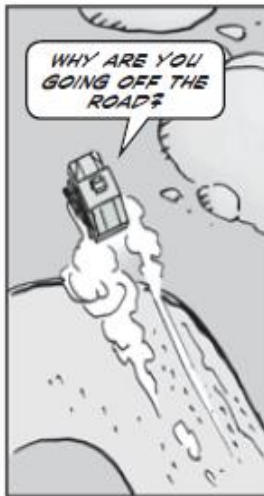
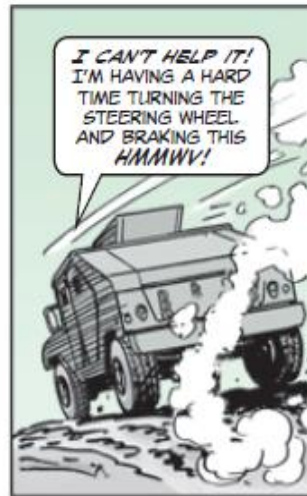
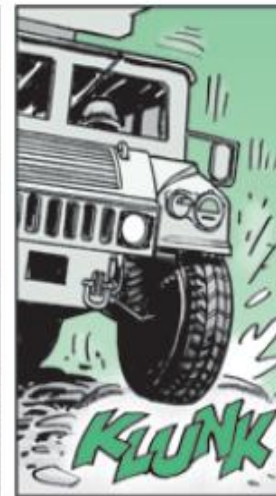
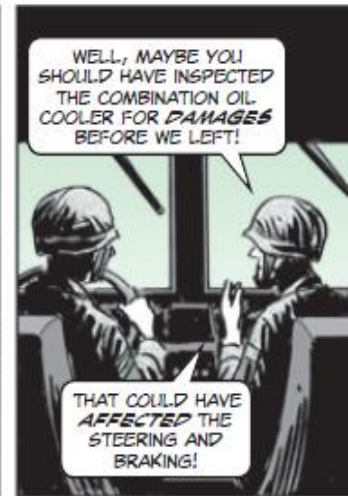
Does your unit have HMMWVs with serial number 300,000 or higher? If so, your HMMWV could have a faulty combination oil cooler.

The combination oil cooler contains engine oil, transmission oil and power steering fluids. Problems with the power steering oil cooler segments have been reported to TACOM LCMC. The power steering fluid flow tubes are located within the center section of the combination oil cooler.

These tubes could expand or rupture during initial engine warm-up or start-up, especially when the vehicle's hydraulic system is cold. A ruptured power steering cooler causes a loss of power steering fluid and pressure, making your HMMWV hard to steer. Braking will also suffer because the power hydroboost is also affected. You don't need hard steering or braking, especially in a war zone!

Avoid this by inspecting the combination oil cooler for ruptures, leaks or swollen tubes like the PMCS table in TM 9-2320-387-10 says. Here's a quick reminder, as it relates to the oil cooler:

1. Both before and after driving your HMMWV, visually check underneath the truck for fluid leaks. If leakage is detected, find the location and cause of the leak. See if that oil cooler is the culprit.

2. Perform a one-minute engine warm-up in normal operations and a three-minute engine warm-up in cold weather operations (32°F and below). And make sure you don't use your steering and braking systems during warm-up! Then, re-inspect the combination oil cooler for leaks.

If you find a faulty oil cooler, your HMMWV is NMC! And it'll stay that way until the combination oil cooler is replaced. By the way, an oil cooler relief valve retrofit kit has been developed to prevent premature failure of the combination oil cooler. But your HMMWV isn't NMC if this retrofit kit is not installed.
